## Tech-Spring Report 15 End Coil Failures

### Introduction

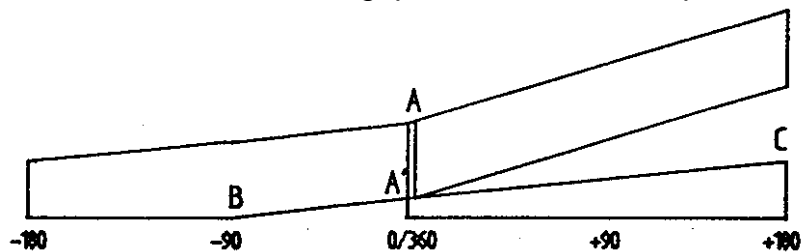
**Figure 1 Spring Design One**

Figure 1 represents the case when the end coil pitch transition AA' occurs at just one coil from the end tip. Figure 2 represents the transition occurring at just less than one coil from the end tip, and Figures 3 and 4 represent AA' occurring at slightly more than one coil from the end tip. The only difference between Figures 3 and 4 being that the end coil pitch is greater in Figure 4 and so there is a small gap between the end tip and the first active coil.

The finite element analysis clearly showed that abnormally high torsional and bending stresses would only occur if the end coil lay-on was as shown in Figure 2 - i.e. the pitch transition AA' occurring just before one complete turn. No abnormally high stresses occurred anywhere in the end coil region for the lay-on shown in Figures 1,3 and 4.

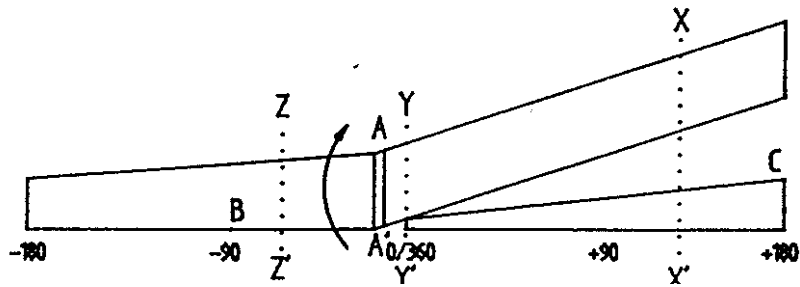
Figure 2 Spring Design Two

It is very difficult to visually identify springs with end lay-ons that correspond to that illustrated in Figure 2, especially since, in practice this transition will be gradual and not nearly so sharply defined as in these diagrams. However, when such springs are identified, observation of the spring action during loading presents some very interesting results. As the spring is loaded to approximately 50% of the available deflection, it will be observed that part of the end coil (up to the position marked ZZ' on Figure 2) lifts off the loading platen. This action is believed to be a consequence of the first active coil of the spring pivoting about the end tip.

It is clear from the foregoing how spring manufacturers should lay their end coils. This advice has been proven to be useful to manufacturers of die springs and diesel engine valve springs. All spring manufacturers will encounter this problem eventually as end users specify lighter compression springs that will inevitably be higher stressed and have a sharper transition from end coil pitch to active coil pitch, in order to make most efficient use of the spring wireform which the spring is made.

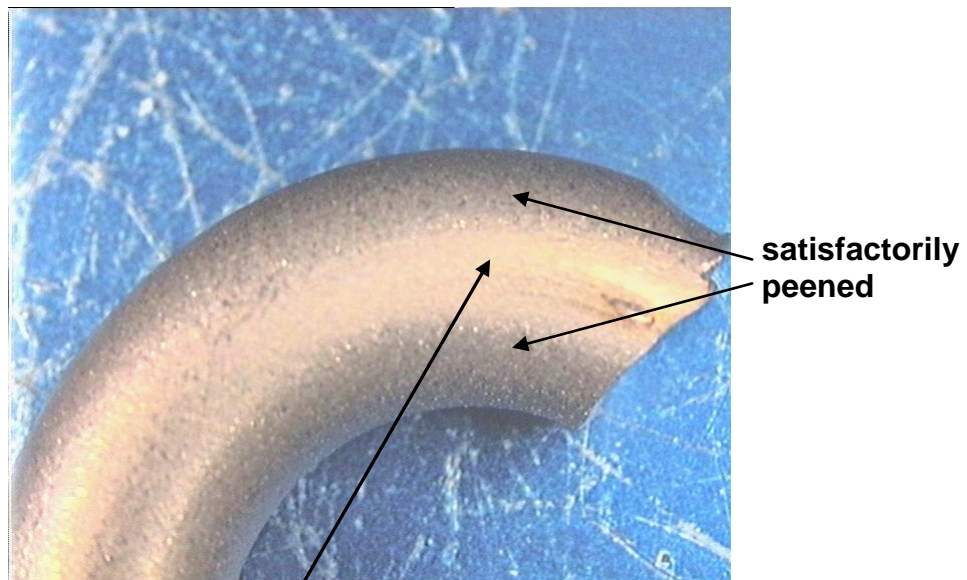
**Figure 2 shadowed area under end tip is not peened.**

Where there is shot peening there will be a residual compressive stress and protection against the risk of fatigue. Where there is no shot peening there will be a residual tensile stress, which will have to be added to any applied stress and the risk of fatigue will be present. It is very important that the applied stress in this shadowed region is very low.

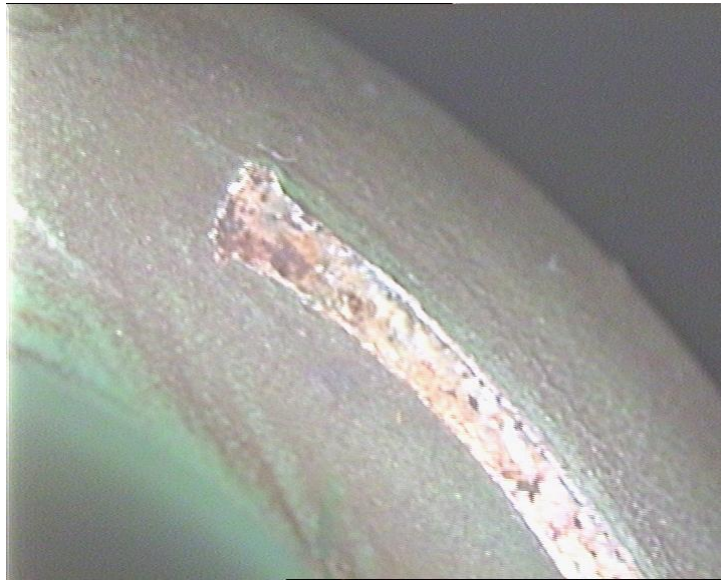
**Figure 3**

This is also inevitable, and will occur at the same shadowed region as in Figure 2. A considerable degree of abrasive wear would have had to occur at this position before end coil fatigue was a possibility. The wear zone is very flat and smooth in cases of abrasive wear, as shown in Figure 3.

The wear in Figure 3 is abrasive, but there is also fretting wear, as evidenced by the red deposit of  $\text{Fe}_2\text{O}_3$  – the fretting oxide accelerates this wear process, but several million cycles are usually required before a risk of fatigue failure arises. Lubrication greatly reduces the fretting.

However, if the contact pressure of this position is great enough the abrasive wear can become adhesive wear and then the risk of failure is greatly increased. Adhesive wear has only been observed in springs with a wire diameter greater than 4mm, but the risk becomes significant at sizes  $>7\text{mm}$ . This type of spring, subject to tens of millions of cycles, will eventually wear out..

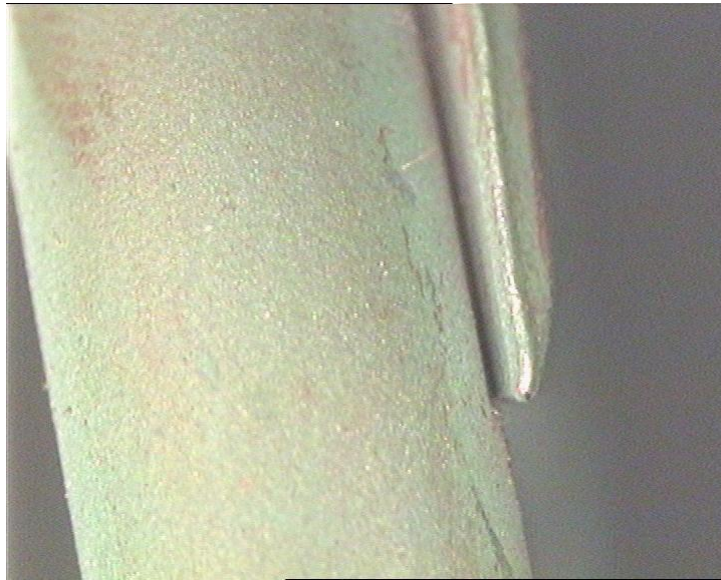
**Figure 4**

If the end coil does not have the same concentricity as the first active coil, there will be a tendency for lateral deflection of the end tip, either inwards or outwards, particularly if it is any thinner than the end tip shown in Figure 4.

Any lateral deflection of the end tip will eventually lead to bending fatigue within the end coil and part of the end coil breaks off.

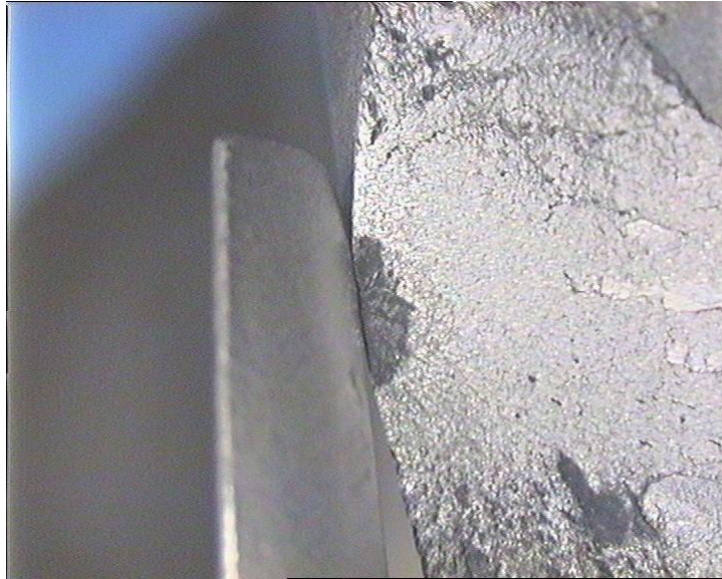
Figure A End coil failure in titanium alloy spring. Fatigue fracture initiated at wear. Dark area at origin is an oil stain. This grade of spring material is more susceptible to wear initiated fatigue failures than any other.

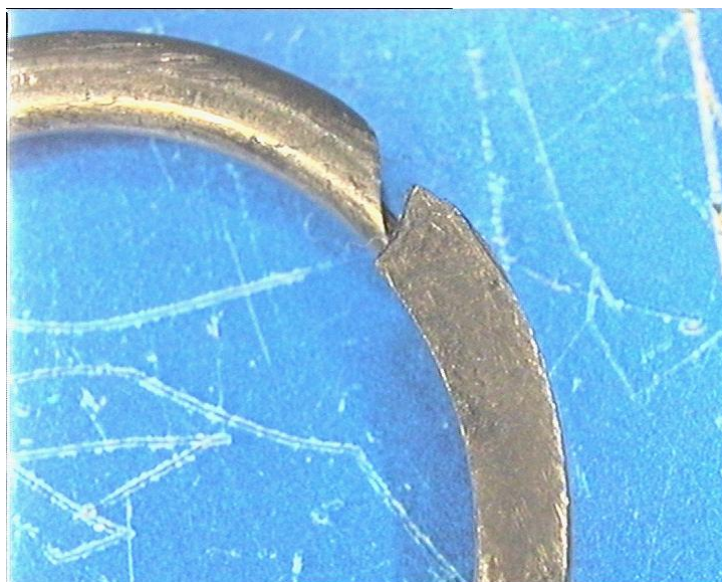
Stainless steel test springs failed due to lateral deflection of the end coil initiated by imprecise spring manufacture. In figure B the lack of concentricity of the end coil itself lead to failure adjacent to the end tip in some springs, but in figure C failure by bending fatigue initiated at half way round the end coil can be observed. This fatigue fracture initiated at the inside corner of the ground end surface. This spring was ground with very fine grit, but this type of failure has enhanced risk if the ground finish on the end coil is abnormally coarse – for instance due to using a grinding wheel with too coarse a grit size.

Figure B End coil not perfectly round. End tip or first coil will be deflected laterally in each loading cycle leading to fatigue failure adjacent to the contact position. Note that the predominant stress is still torsional in this failure

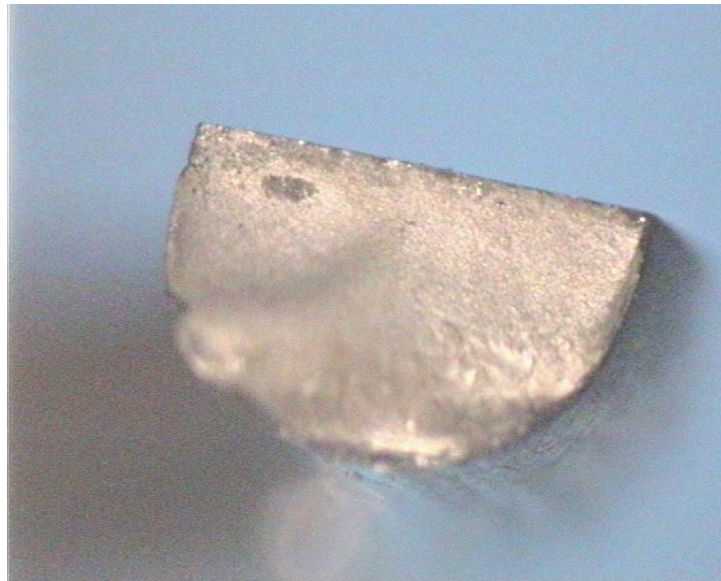
Figure C Same batch of springs as in figure B, but this spring failed by bending fatigue initiated at the inside corner of the ground end
