Tech-Spring Report 15 End Coil Failures

15.1 End Coil Modelling

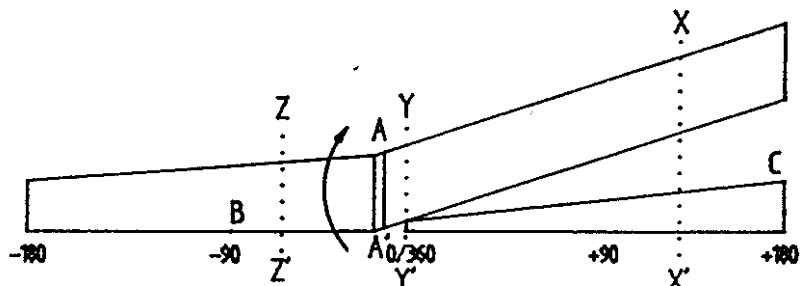
Figure 2 Spring Design Two

The finite element analysis clearly showed that abnormally high torsional and bending stresses would only occur if the end coil lay-on was as shown in Figure 2 - i.e. the pitch transition AA' occurring just before one complete turn. No abnormally high stresses occurred anywhere in the end coil region for the lay-on shown in Figures 1,3 and 4.

It is very difficult to visually identify springs with end lay-ons that correspond to that illustrated in Figure 2, especially since, in practice this transition will be gradual and not nearly so sharply defined as in these diagrams. However, when such springs are identified, observation of the spring action during loading presents some very interesting results. As the spring is loaded to approximately 50% of the available deflection, it will be observed that part of the end coil (up to the position marked ZZ' on Figure 2) lifts off the loading platen. This action is believed to be a consequence of the first active coil of the spring pivoting about the end tip.

It is clear from the foregoing how spring manufacturers should lay their end coils. This advice has been proven to be useful to manufacturers of die springs and diesel engine valve springs. All spring manufacturers will encounter this problem eventually as end users specify lighter compression springs that will inevitably be higher stressed and have a sharper transition from end coil pitch to active coil pitch, in order to make most efficient use of the spring wireform which the spring is made.

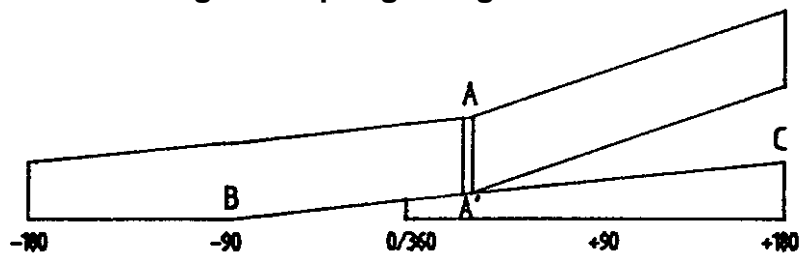
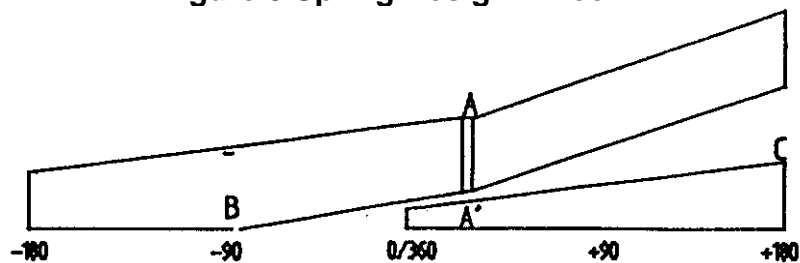
Figure 1 represents the case when the end coil pitch transition AA' occurs at just one coil from the end tip. Figure 2 represents the transition occurring at just less than one coil from the end tip, and Figures 3 and 4 represent AA' occurring at slightly more than one coil from the end tip. The only difference between Figures 3 and 4 being that the end coil pitch is greater in Figure 4 and so there is a small gap between the end tip and the first active coil.

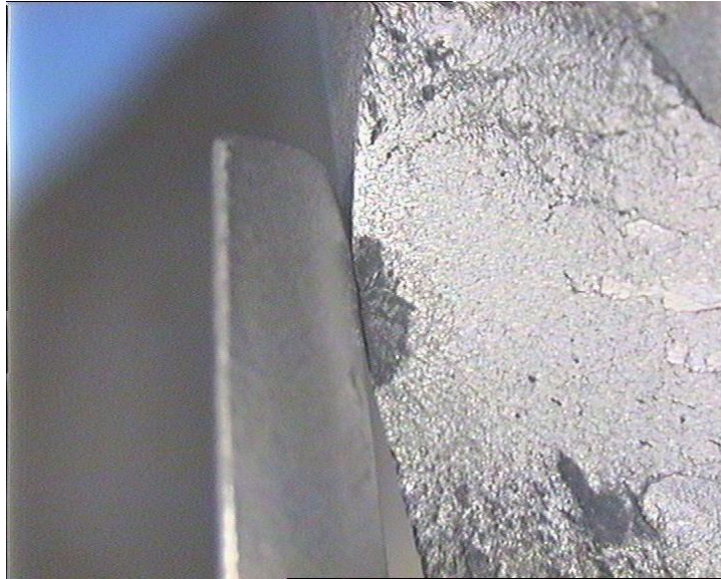
Figure A End coil failure in titanium alloy spring. Fatigue fracture initiated at wear. Dark area at origin is an oil stain. This grade of spring material is more susceptible to wear initiated fatigue failures than any other.

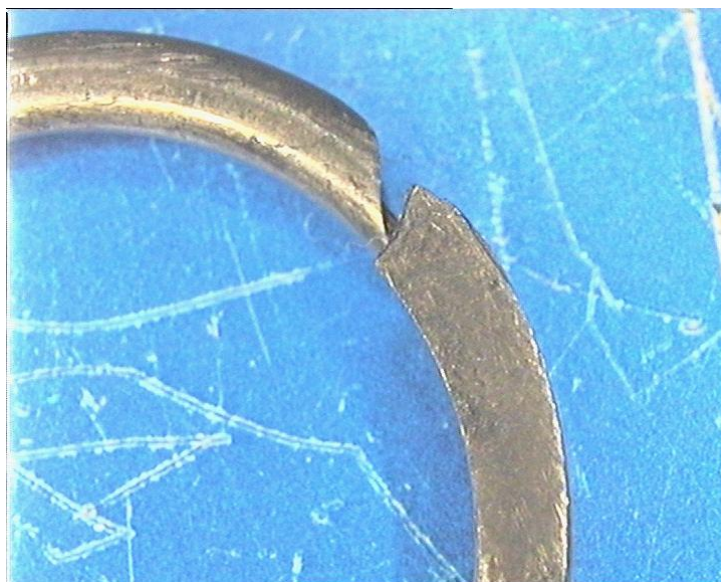
Stainless steel test springs failed due to lateral deflection of the end coil initiated by imprecise spring manufacture. In figure B the lack of concentricity of the end coil itself lead to failure adjacent to the end tip in some springs, but in figure C failure by bending fatigue initiated at half way round the end coil can be observed. This fatigue fracture initiated at the inside corner of the ground end surface. This spring was ground with very fine grit, but this type of failure has enhanced risk if the ground finish on the end coil is abnormally coarse – for instance due to using a grinding wheel with too coarse a grit size.

Figure B End coil not perfectly round. End tip or first coil will be deflected laterally in each loading cycle leading to fatigue failure adjacent to the contact position. Note that the predominant stress is still torsional in this failure
